An excellent, traditional pub serving fresh food, cask ales and fine wines

Cheshire EHO had to intervene with this successful pub, due to complaints from local residents

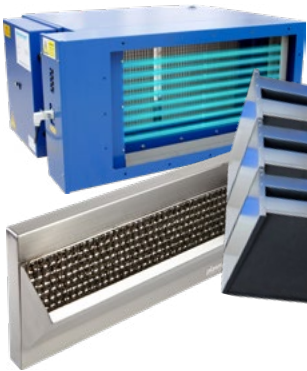
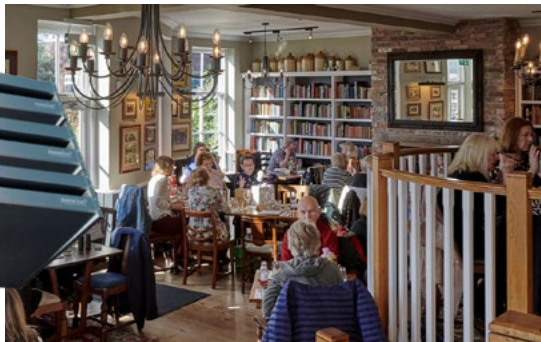
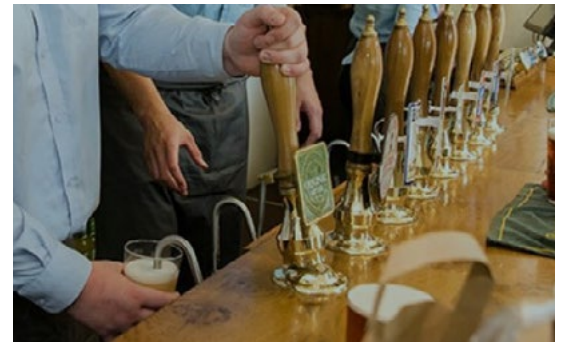
Plasma Clean's high efficiency Coil Filters were the starting point - to remove nearly 100% of grease. These were combined with an Electrostatic ESP UV, to keep ductwork free from remaining grease. As a final polish, our Activated Carbon was installed to remove residual ozone before extraction, as well as further oxidising any residual odour molecules that become trapped on the activated carbon surface. Vital when the extraction point is low, or when it's close to an open window or an air-intake louvre.

Complete reduction in kitchen odours, grease and smoke. Five years after the installation, the extract run remains grease free and the ductwork is only inspected in line with TR/19 requirements. This has saved considerable duct cleaning costs. *"Complaints from neighbouring properties caused by cooking smells have stopped since this equipment was installed."* - Manager
