## American Diner, serving classic USA eats in Manchester's Northern Quarter

A busy city centre restaurant with low level extraction near neighbouring properties

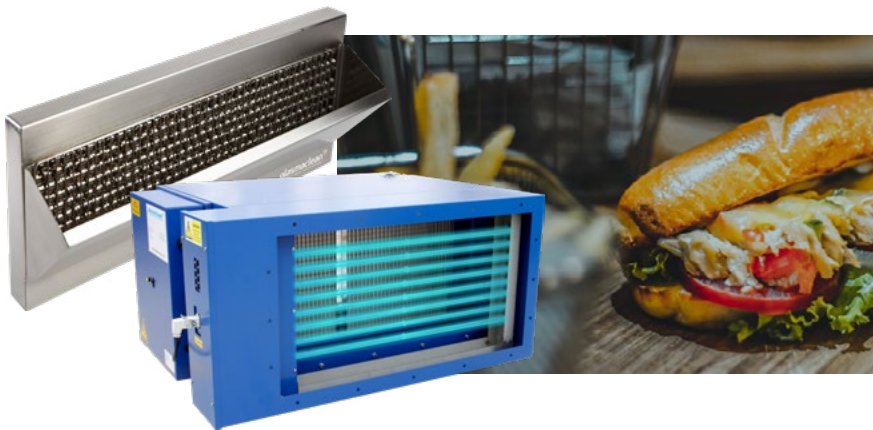
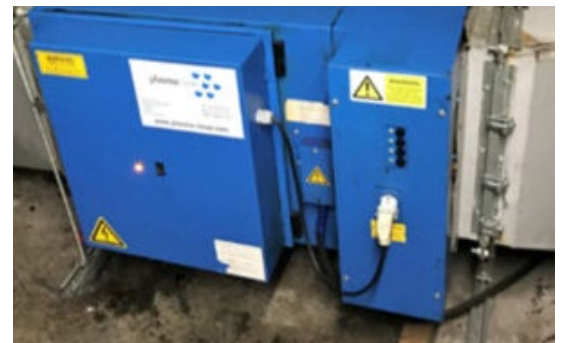
Dramatically reduced the grease build up in the system. From the relatively clean coils on the back of the filter, only a small amount of grease had penetrated through - as promised. The ESP UV system had eradicated most grease, grime and germs you would normally find downstream in the ductwork.

High efficiency Coil Filters were installed in the canopy, capturing 95% of grease particles. Then, our Electrostatic UV was installed into their ductwork, keeping extraction ducts virtually grease-free.
